Edina's Drinking Water Is Certified Safe

The City of Edina is working to hold accountable those responsible for contamination of local groundwater. Drinking water is certified safe because it is treated, but the City wants the original polluters identified and held accountable for cleanup expenses.

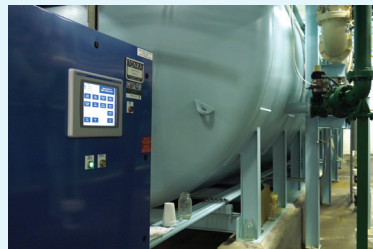
3 Water treatment filters out contamination
With a pricetag of about \$8 million, Water Treatment Plant 6 opened in 2012, treating water from four of Edina’s wells, including Well No. 7. The plant is equipped with an aeration system designed to filter out vinyl chloride. It costs about \$440,000 annually to operate.
